Case 251 : Narrative

Case Vehicle (A): 1999 Mercury	Vehicle (B): 1999 Ford
Type: Grand Marquis LS, 4-door sedan	Type: F150 Supercab Pickup 4x4
Driver: 73-year-old female	Driver: 28-year-old male
CDC: 12-FDEW-2	CDC: 99-0000-0

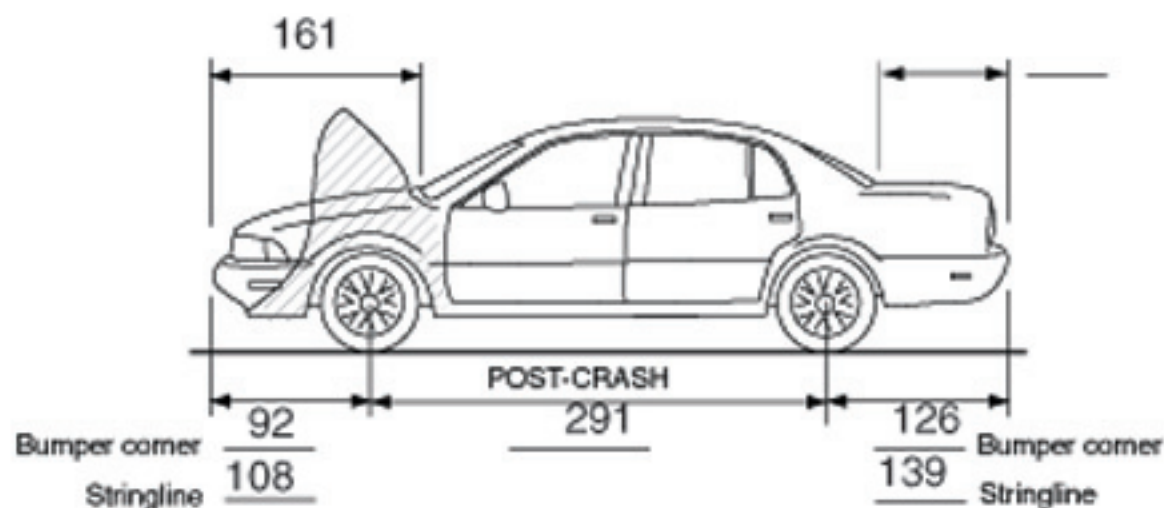
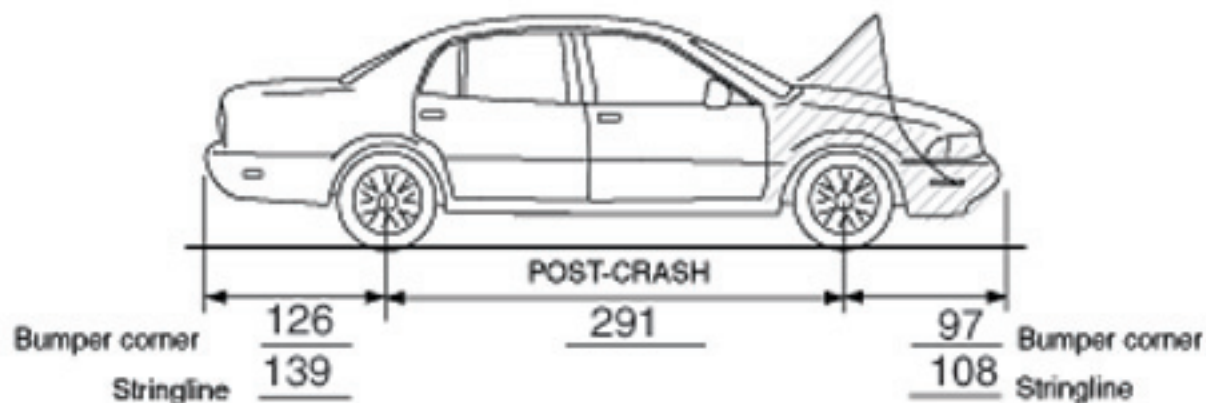
[5](#) The direct damage to case vehicle (A) began at the left-front bumper corner and extended 150 cm across the entire front. The maximum crush was 60 cm to the center portion of the radiator above the bumper.

150 cm
direct damage
60 cm max crush
above the bumper

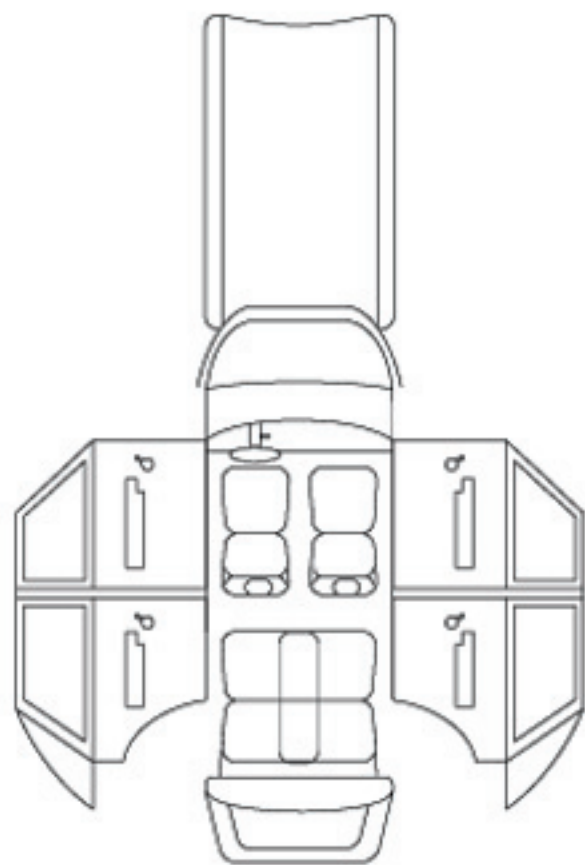
DR belt: positioned low on B-pillar

Evidence of belt use: yes -
marks on webbing
light scratches on D-ring
